# First Floor Flat Refurbishment

## Before

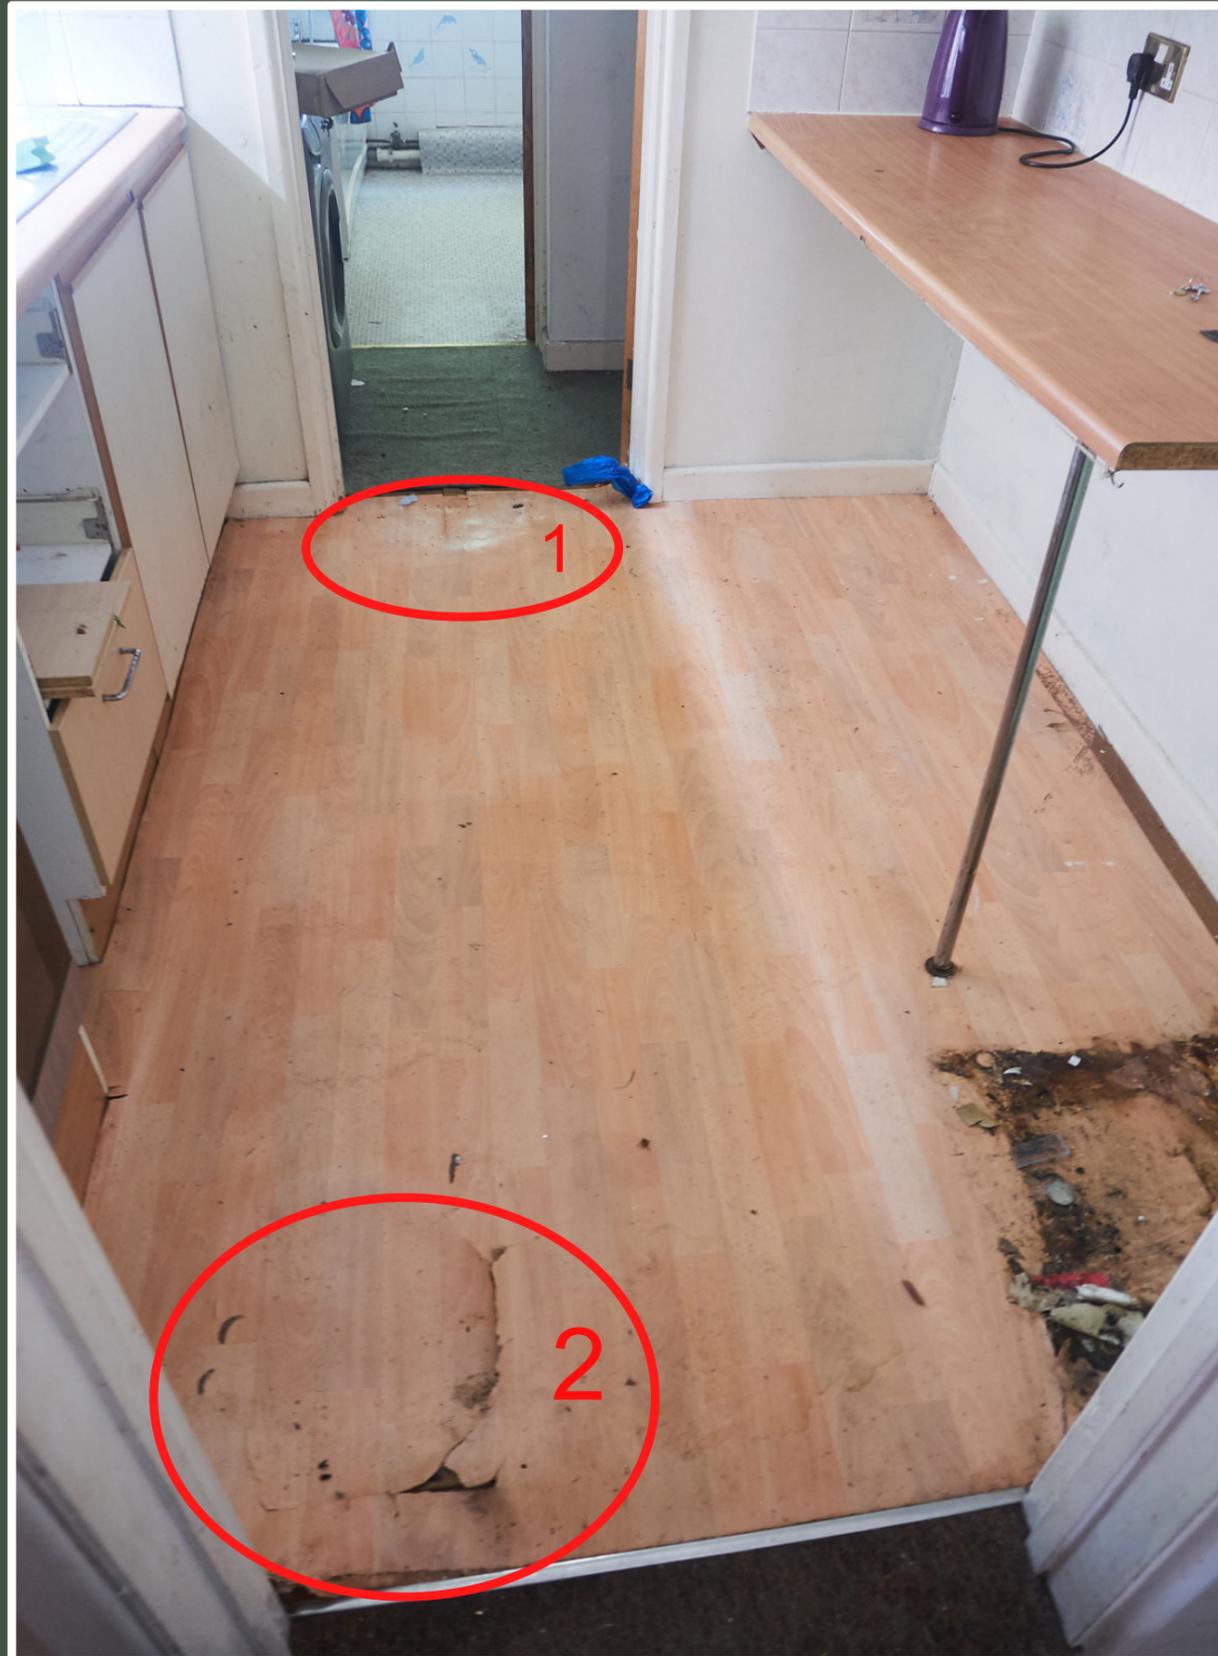
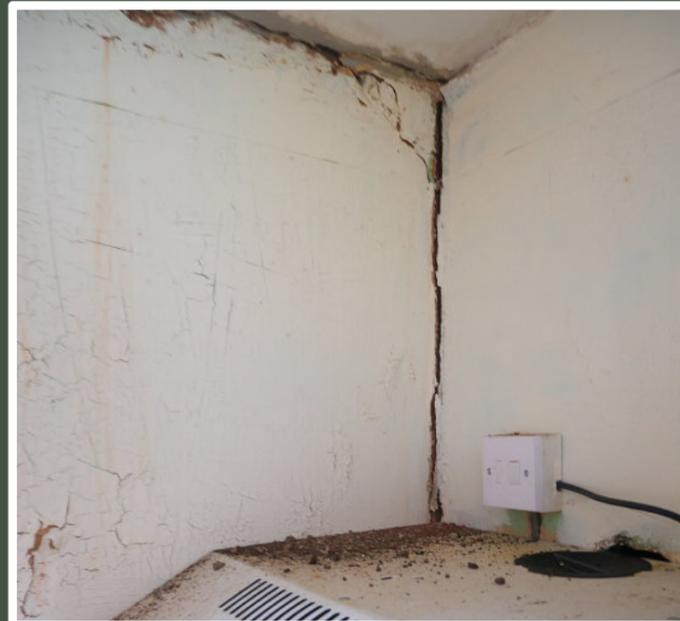
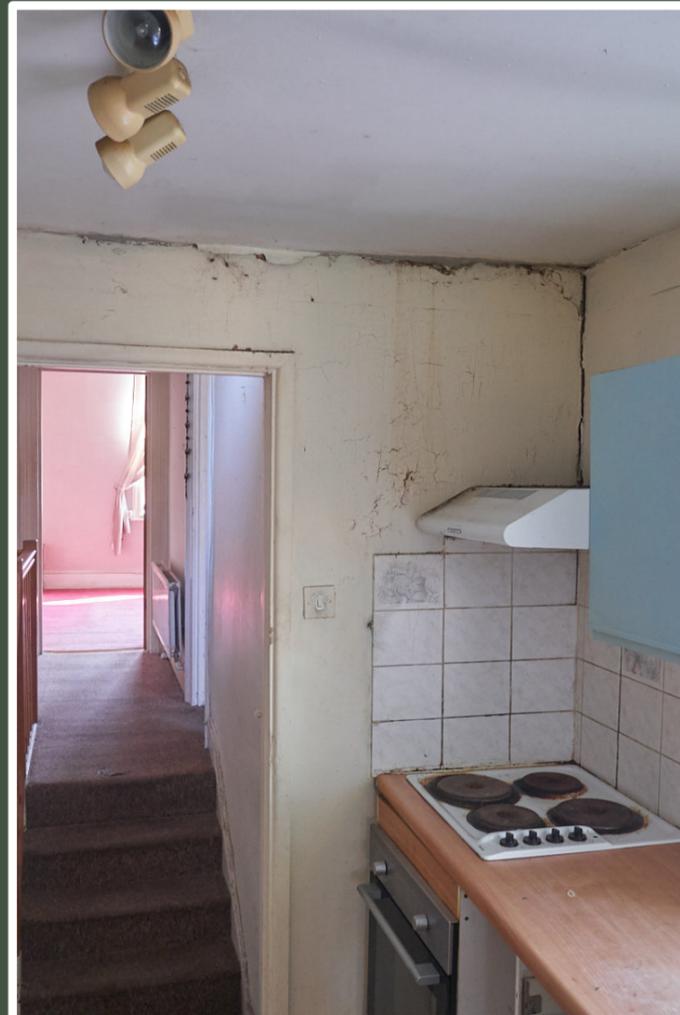
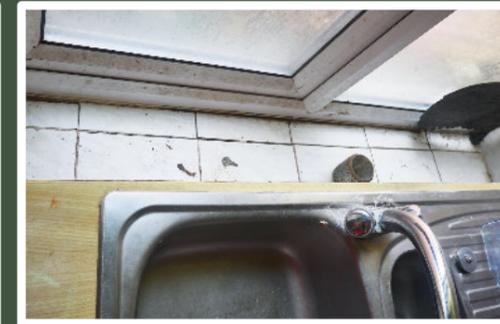
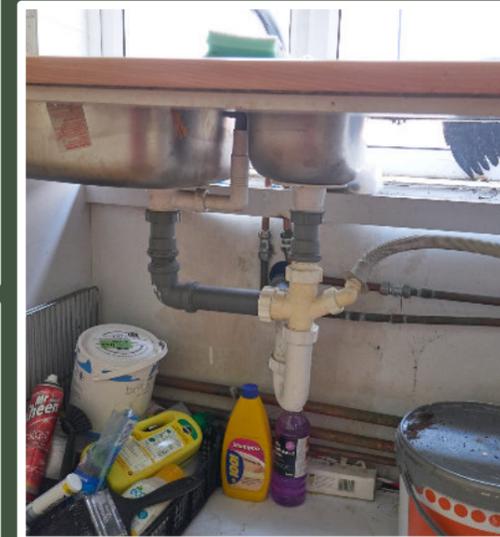
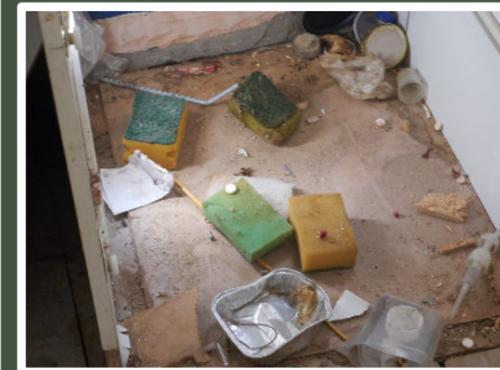
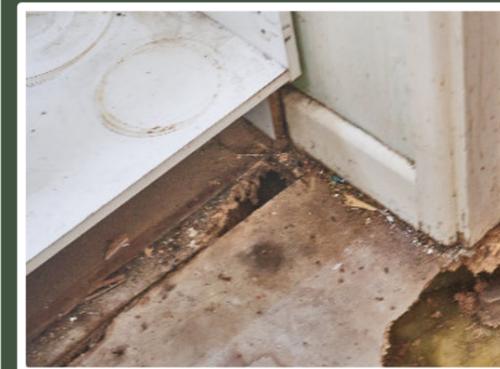
### Kitchen

As well as the kitchen being in generally poor condition, the floor had 2 quite dangerous holes (circled in red). These were the result of water damage & poor choice of floorboard.

The end wall between the kitchen & bedroom was damp. Building settlement had caused a gap at roof level. This, together with cracked render & poor detailing allowed water & sediment to enter the room as seen on the cooker hood.

The area around the sink was a problem because the window cill was lower than the worktop, not only making it difficult to reach/clean, but easy to lose items behind the (remains of) the cabinet.

The floor structure had to be adapted to fit new boards. The bottom right photo shows part of hole (1) in the floor. The small hole in the photo, was aligned with the edge of the old vinyl (removed), so may have been caused by mice, which had also damaged much of the electric cabling beneath the floor. For this reason copper pipes were used for the new water supply.

The layout has only changed slightly. The hob moved to give space on either side & so legalises the switch position. The window cill raised to make cleaning easier. A dedicated cupboard was built to house the fridge & prevent as much dirt collecting beneath.

Serviceable appliances were reused for cost & environmental reasons. Sink, cooker hood, oven & even some tiles were also salvaged & reused.

A new water supply was installed in the flat so the plumbing had to be re-jigged. A 22mm copper pipe was built behind the units. To avoid ripping them out, should the gas boiler need replacing. The floor perimeter was sealed to help mitigate potential flood damage below.

The gap at ceiling level was filled & sealed with PU sealant & coving added to neaten the appearance. The external leak was subsequently fixed, after this project was completed.

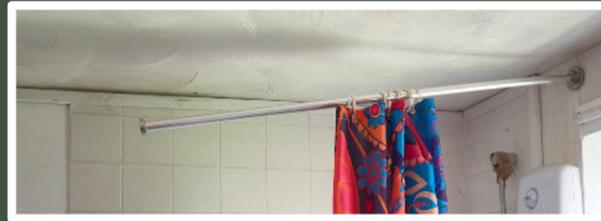
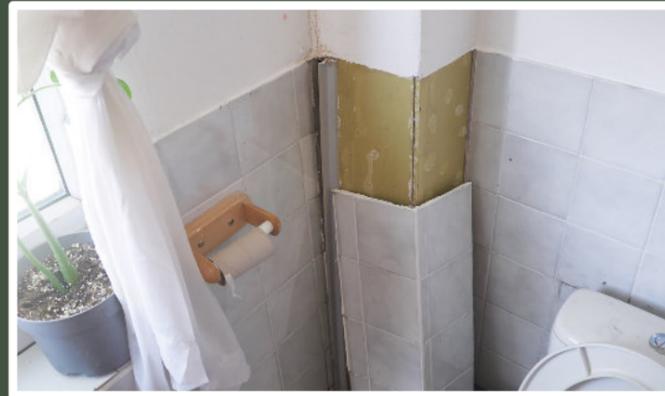
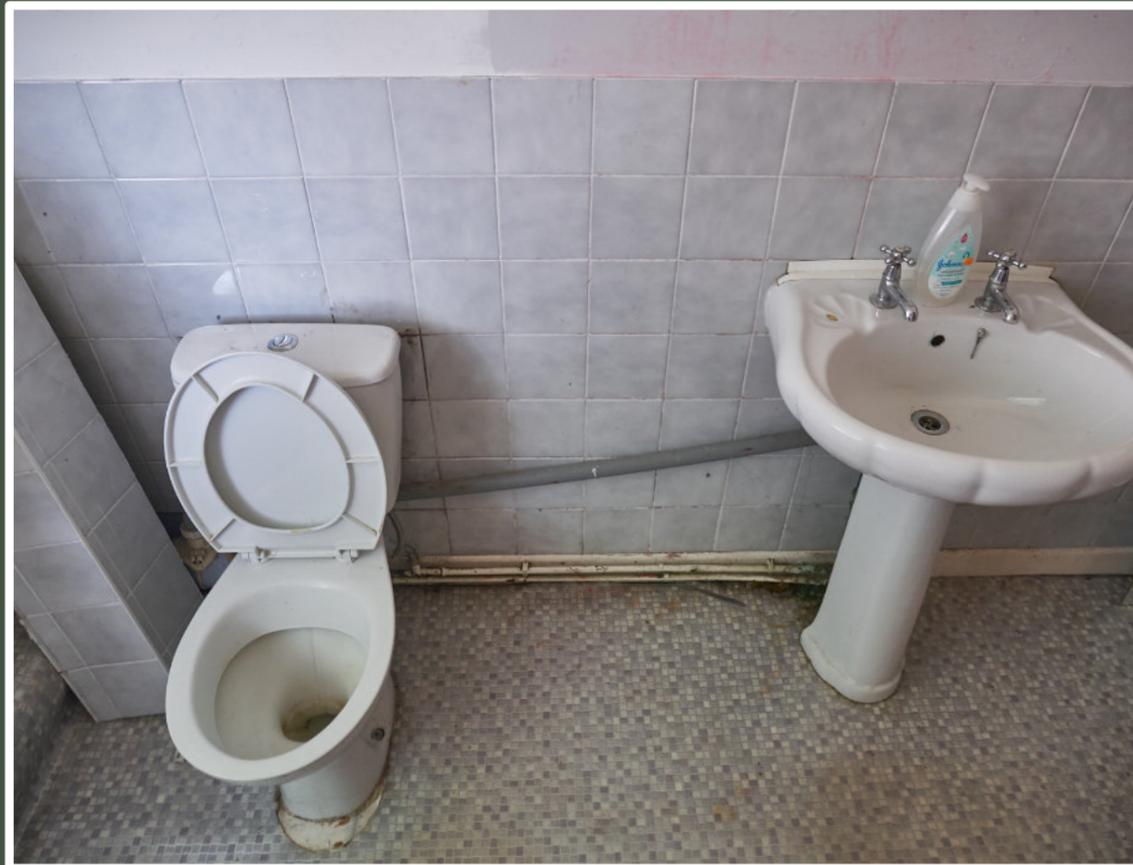
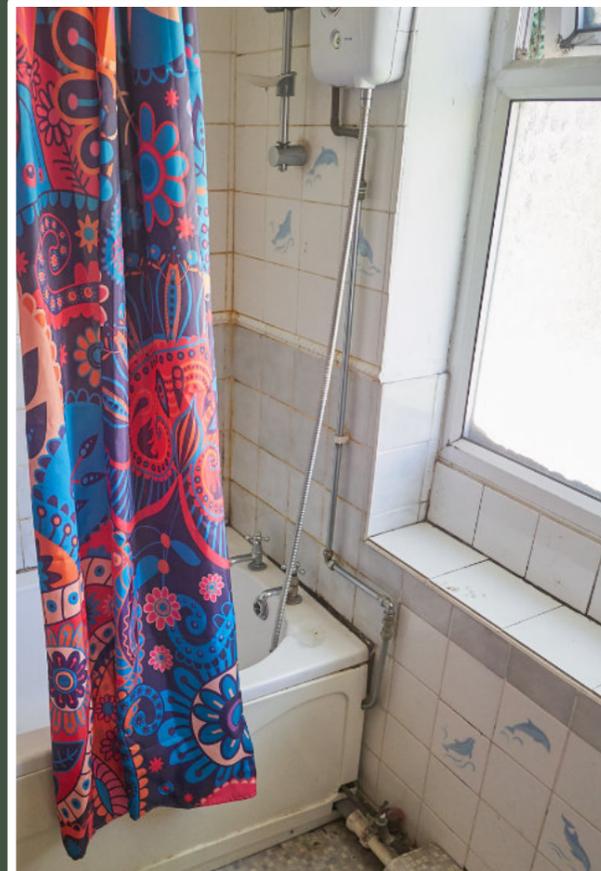
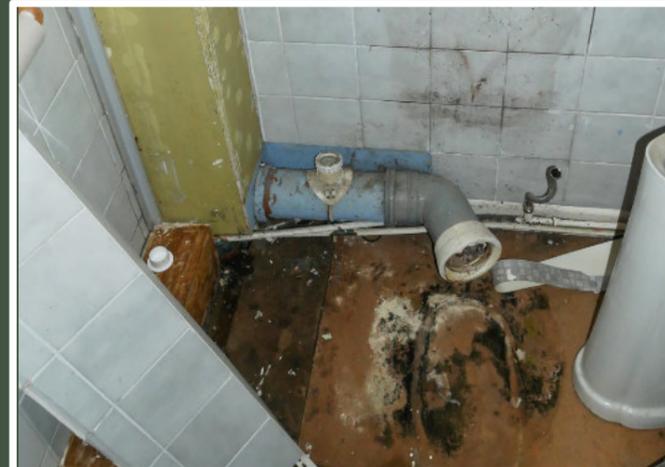
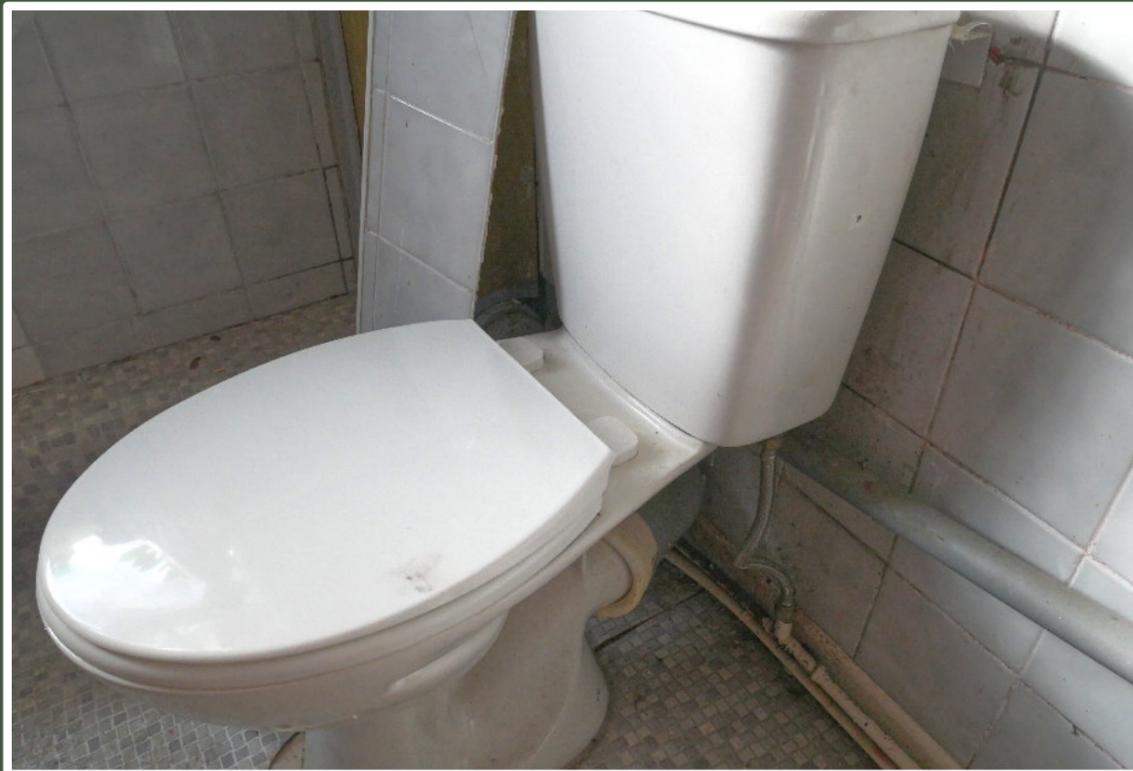
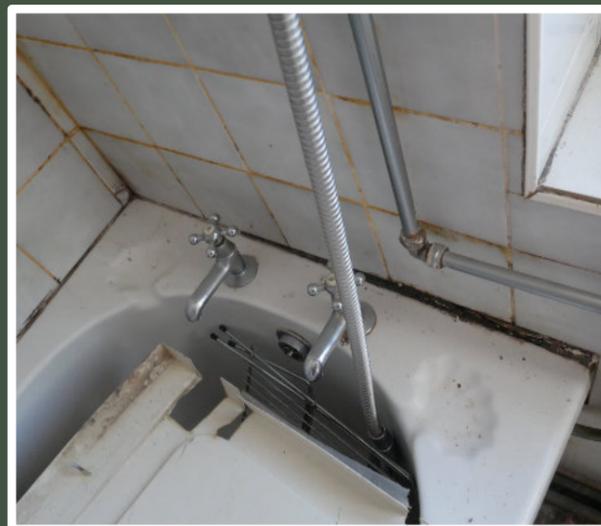
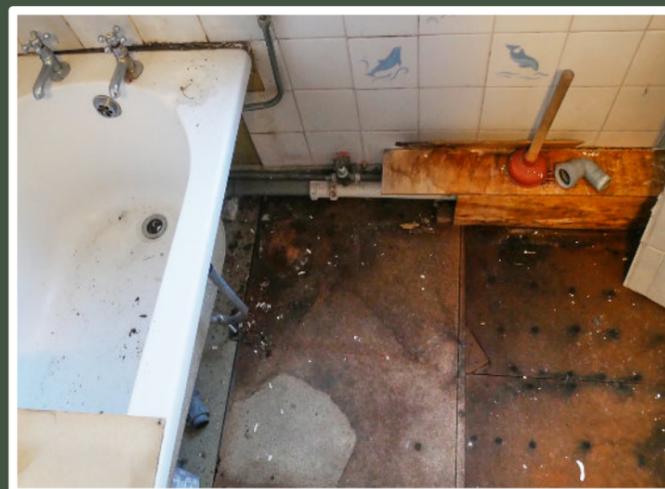
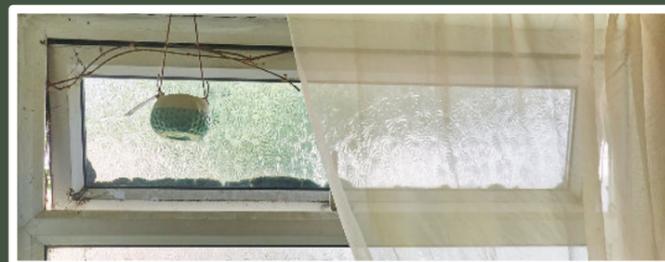
### Bathroom

The bathroom had evidence of bodged repairs over the years. These may have taken their toll on the effort that went in to further basic maintenance.

The shower plumbing was a hodgepodge of odd pipes & connections, the shower bracket was broken & the curtain rail bent. Limescale had built up on the tiles & taps & the seal around the edge was mouldy & leaking water into the flat below.

The plumbing of the basin & toilet left quite a lot to be desired, most of the pipes were not boxed in, making them difficult to clean. The pan waste was misaligned & the cistern wobbled, because it was glued to a plastic angle that was becoming unstuck from the wall.

Tiles around the soil stack had come off & there was dampness in the floor in the general area.

The window catch had corroded preventing the window closing properly. Plants had begun growing in. Though what came first I don't know, plants or rust.

The bathroom suite was removed, repairs made & plumbing reconfigured for neatness, ease of maintenance & not least, to accommodate the new water supply. Waste pipes for the toilet & sink were also replaced with appropriate fittings so should function better. The toilet cistern is now fixed, conventionally, to the wall.

A new bath panel was needed & the shower bracket & curtain rail were replaced. Taps & tiles were descaled & loose tiles reattached.

The floor perimeter was sealed similar to the kitchen to mitigate water damage below.

The corner was modified so that the gap between the bath & tiles reduced. A good seal was made & then finished with plastic trim to look neater.

All pipes were fully boxed in at floor level, with access points given for isolation valves. Again, this should make maintenance & cleaning easier.

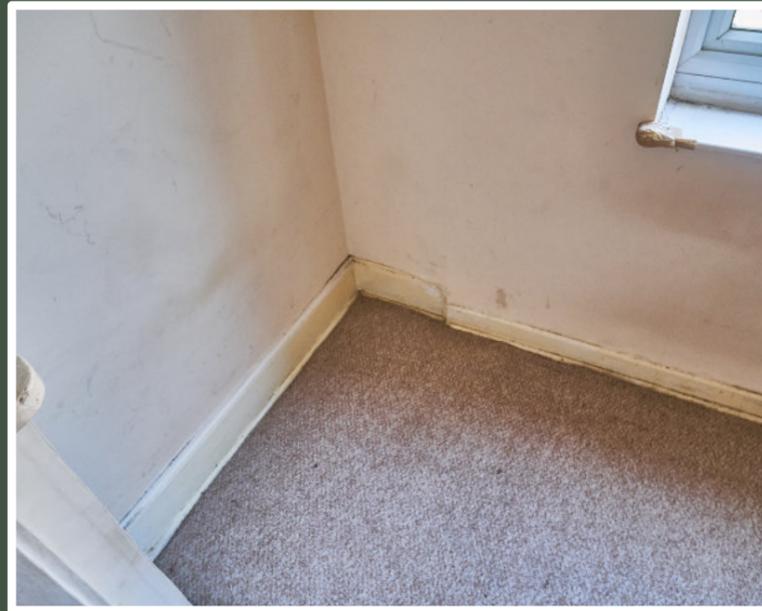
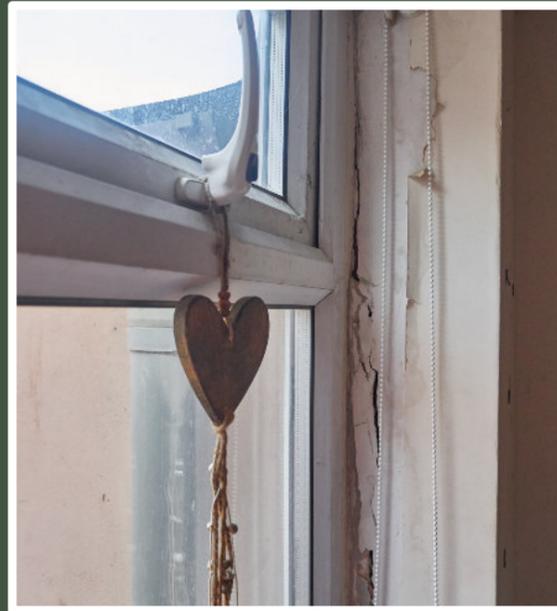
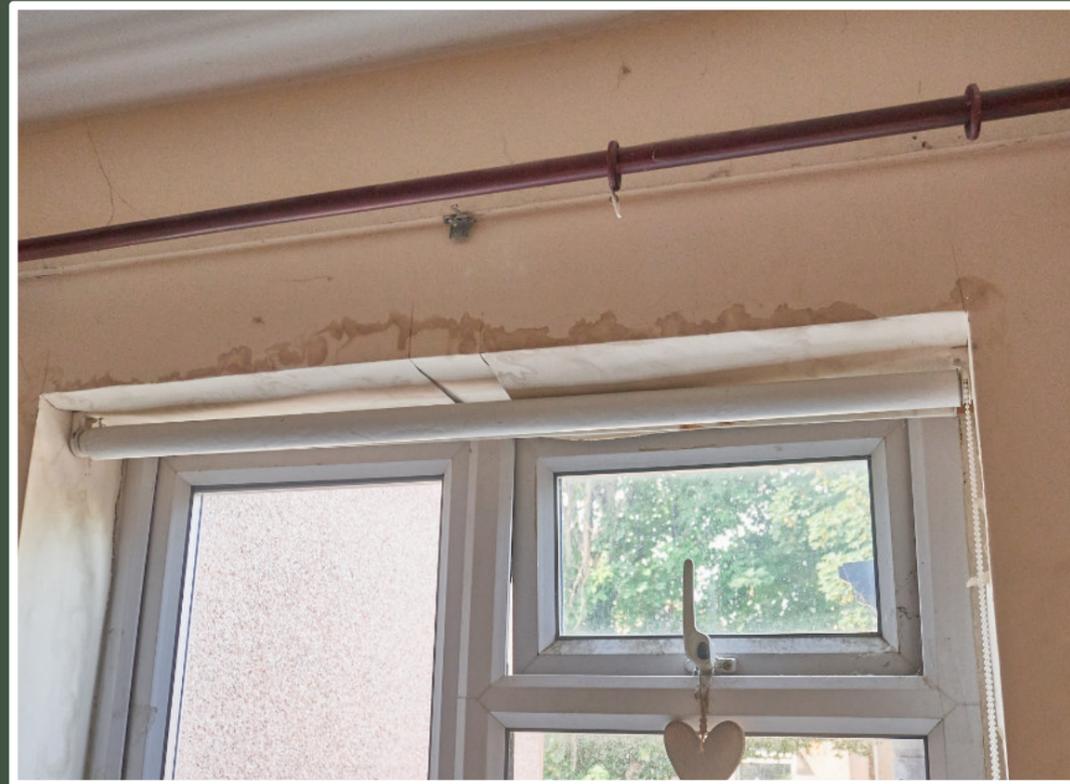
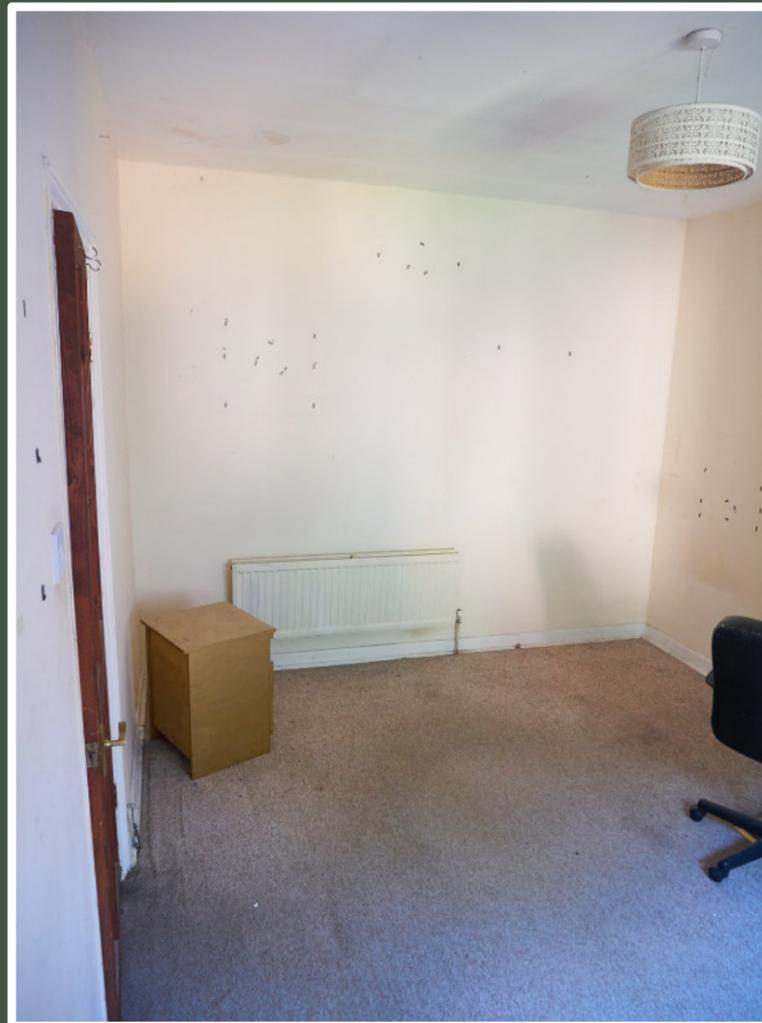
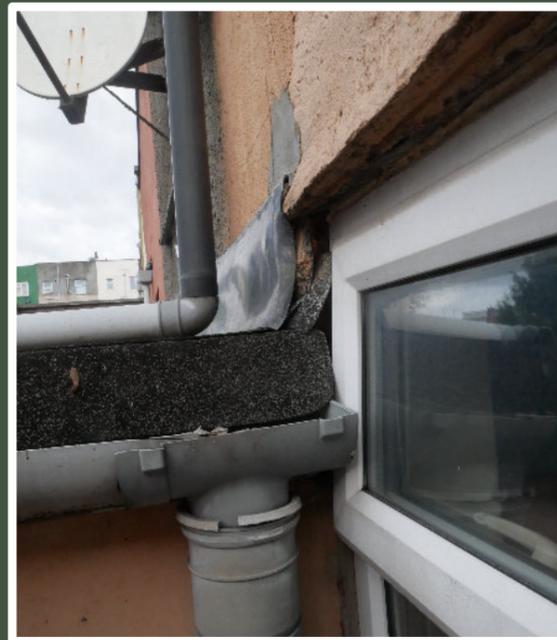
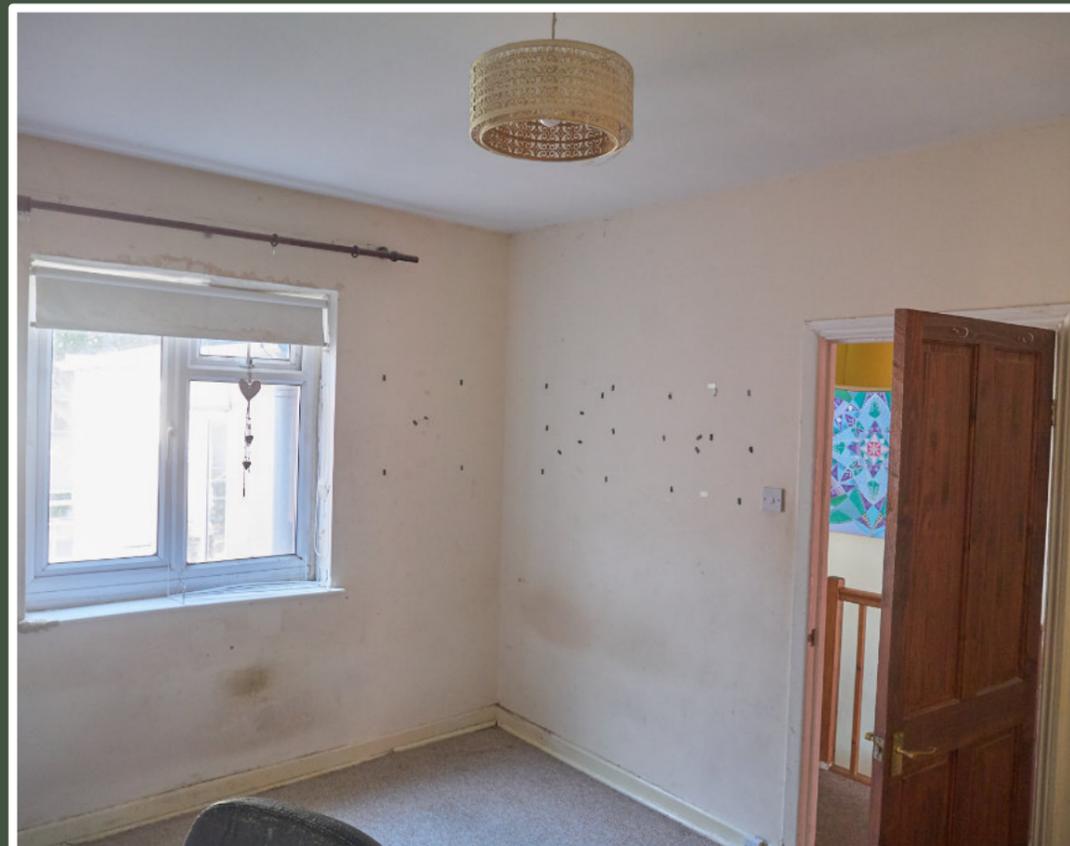
## Bedroom

Part of the external wall looks to have been rebuilt in the late 20<sup>th</sup> century. There are signs of movement between the kitchen extension & the main house & similar movement can be seen in the neighbours.

The window surround had obvious signs of damp. The casement & glazed unit seals had failed & the frame/wall seals were also defective. The window itself, undersized for the opening, was set too far forward (it can only be partially opened). It narrowly straddles the line between the external render & brickwork. The cracked render was thus another source of damp as rain could trickle behind the render & track into the room once it reached the frame.

The radiator was in an inconvenient place & only held up by the connecting pipes, because whoever installed them (1970s/80s) skimped by sawing each bracket in half & only securing the upper cleat to the wall. They had worked loose over the years.

The floor too needed extensive repair.

There were many loose & broken floorboards in the bedroom, these were replaced with sheet material which should make for a stiffer & quieter floor & may improve acoustic performance between the flats. Mineral wool was placed in the voids for the same reason.

The window did not get replaced, rather a shame because the seals are still broken & the top light cannot be opened. That said, I believe the damp problem is fixed.

In the 'before' photo you may see the remains of 'Sticky Fixers'. These were used to mount acoustic foam to the walls & ceiling (the previous occupant was a professional music producer). These remains could not be over-painted so each one had to be abraded to remove it & the surface re-primed before painting.

The radiator was removed, serviced & relocated to a better position, giving just enough space to place a double bed against the wall & gain access to either side.

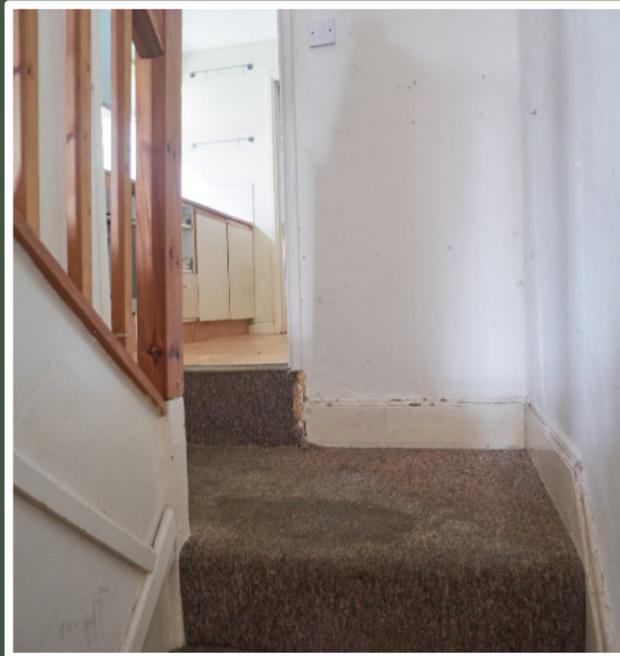
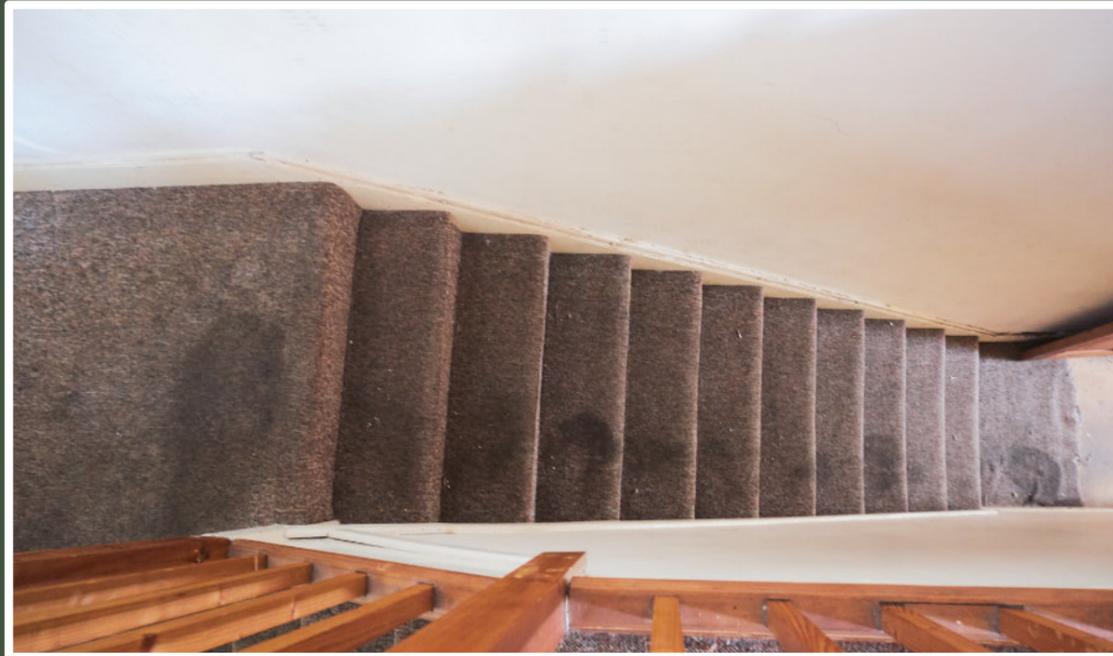
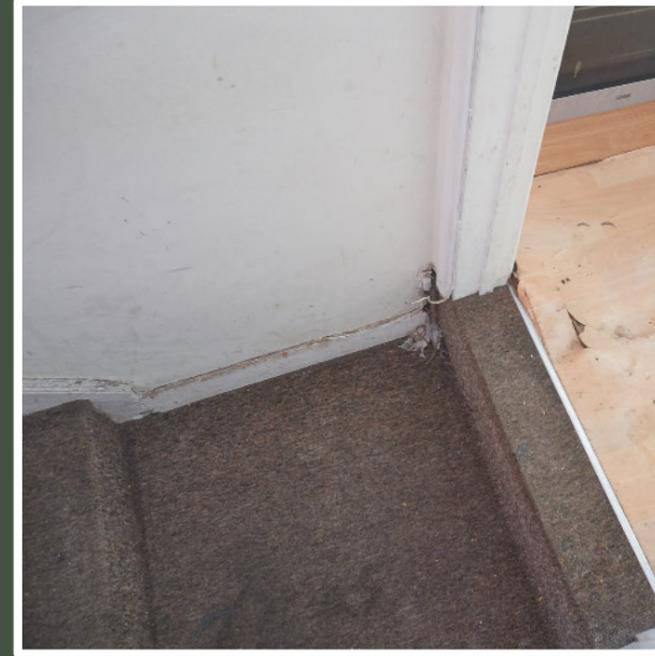
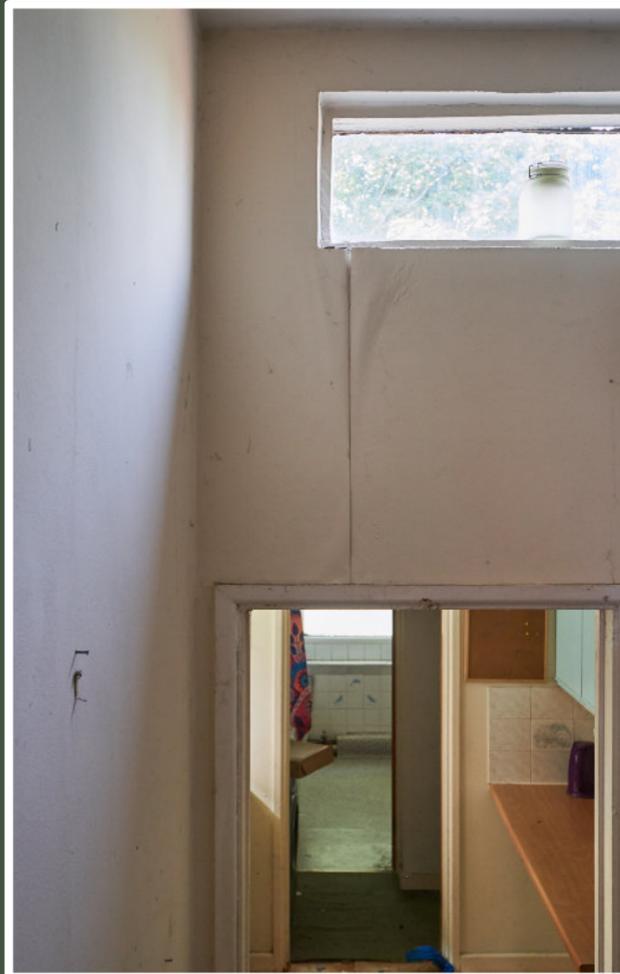
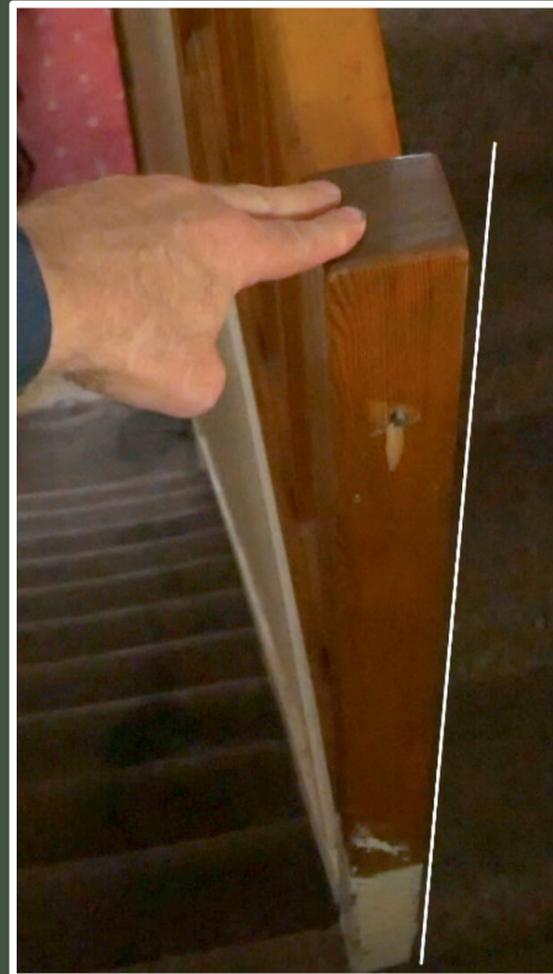
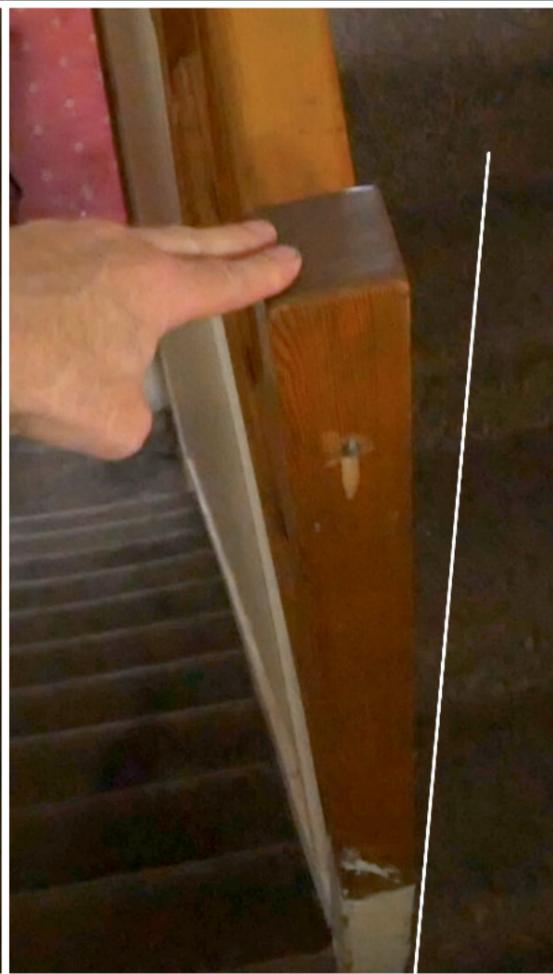
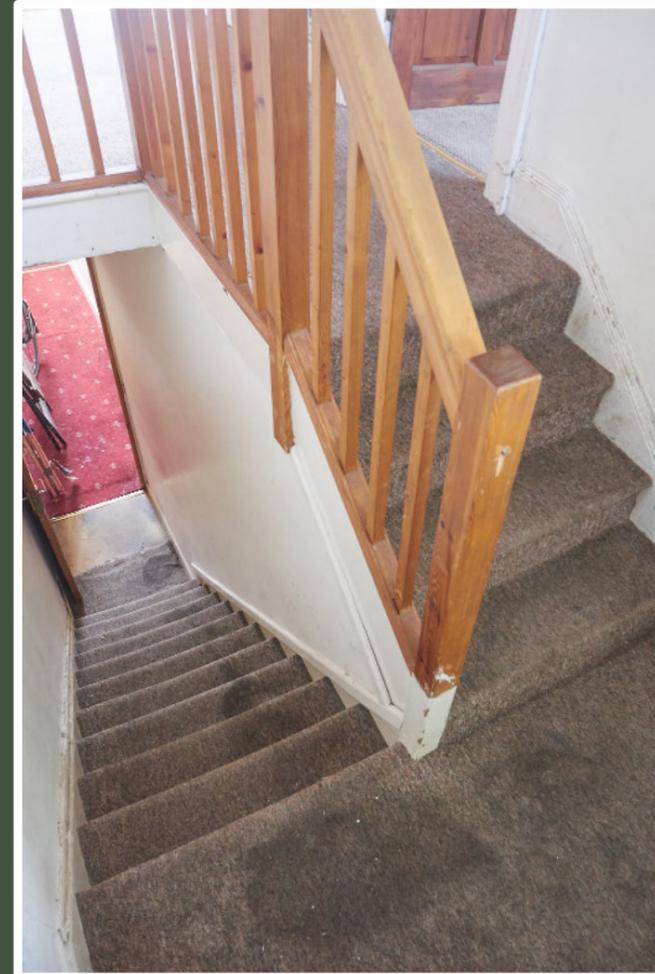
## Hallway & Staircase

However the floor & treads were creaky & the newel post wobbled at the slightest touch. Combined with the lack of handrail on the main flight, it posed risk to anyone less able bodied.

The layout was awkward at the half landing. A very high, single step up into the kitchen, after a step down, from the living room side, was annoying.

The external wall adjoining the kitchen was damp, so too was the flanking/party wall between the next door neighbour. The source was likely to be as mentioned previously.

The window is nothing more than a piece of glass set into the external render. On inspection there was insufficient evidence to determine if it was a source of damp but advice was given to install a more conventional window.

The staircase & hallway floor renovation, included adding a quarter landing & handrail.

The new landing is at the same height as the existing bottom step of the top flight, so walking up or down seems natural.

A metal nosing was fitted to the kitchen step to protect what otherwise would have been painted wood. A shallow piece of skirting protects the bottom of the wall adjacent to the bedroom & gives a neat appearance.

The newel post was reinforced with a steel dowel, good glue, timber & screws & no longer wobbles.

Several damaged stair treads were repaired with timber salvaged from the bedroom floor.

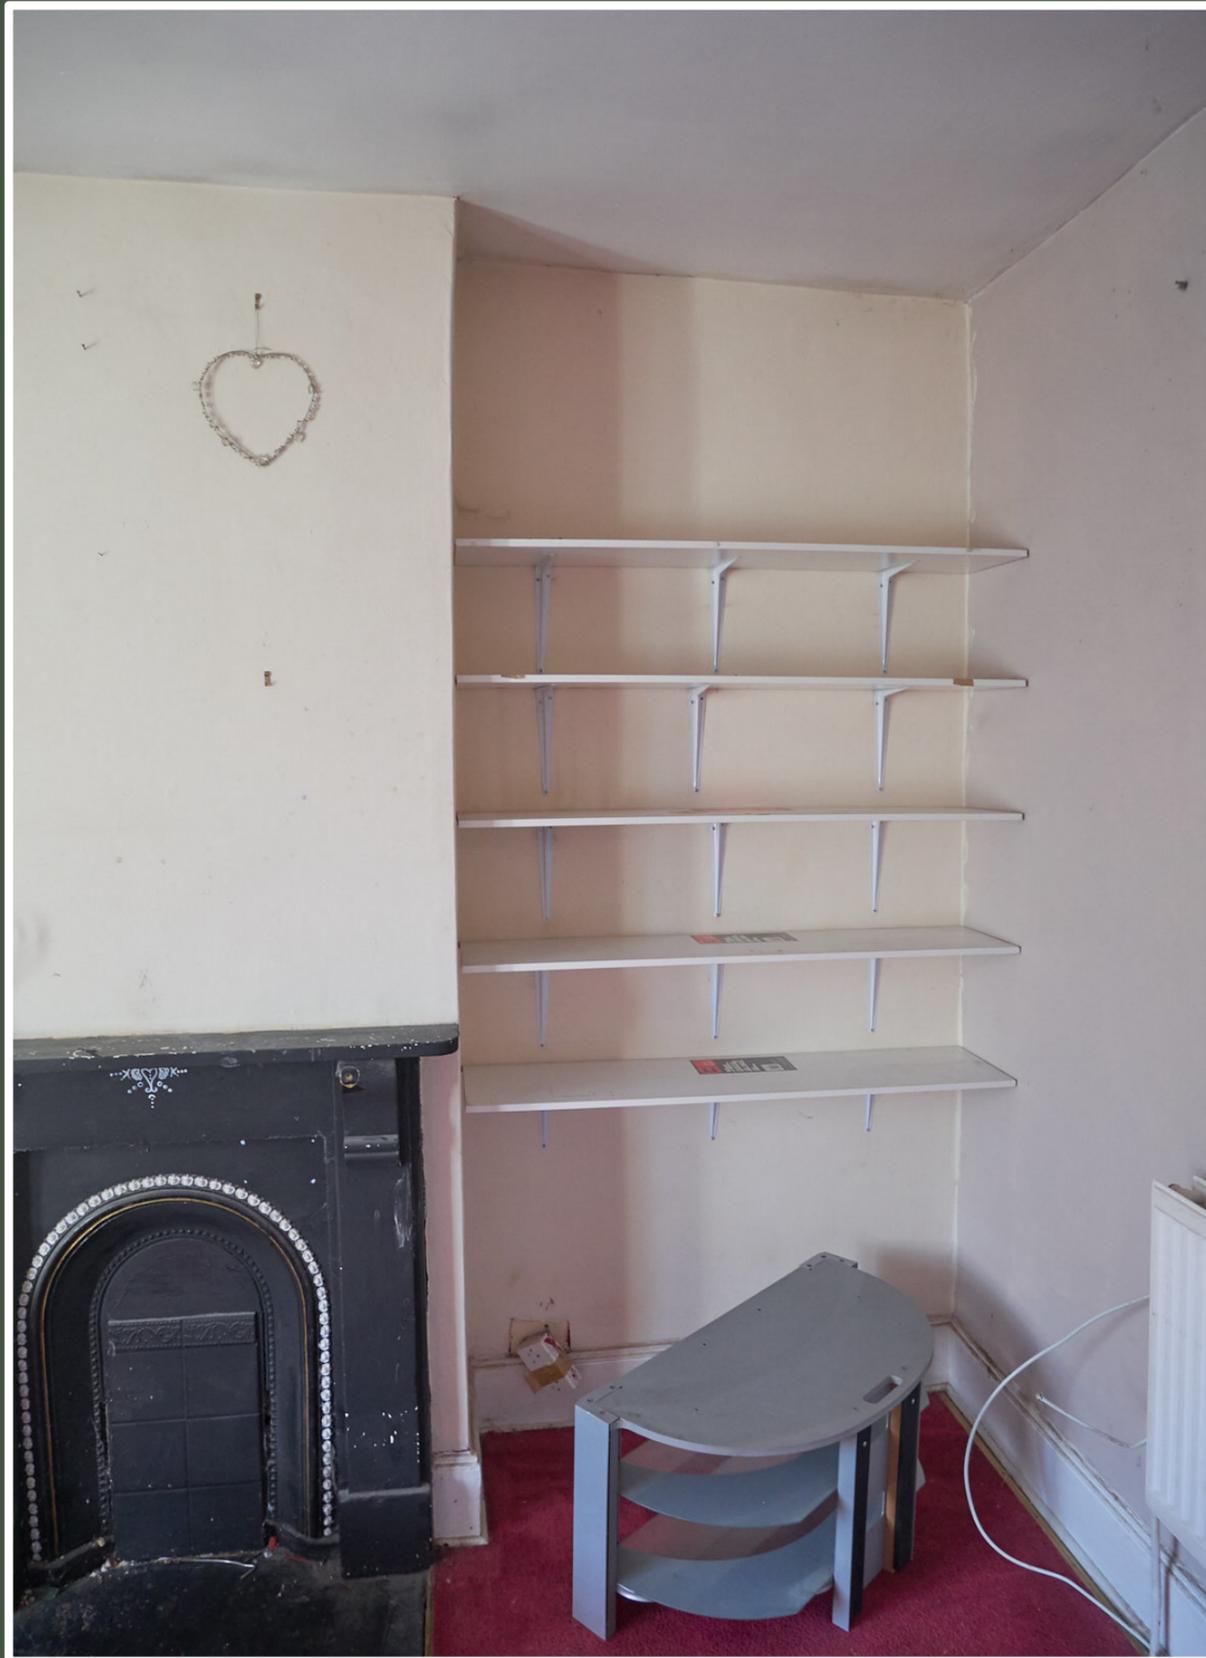
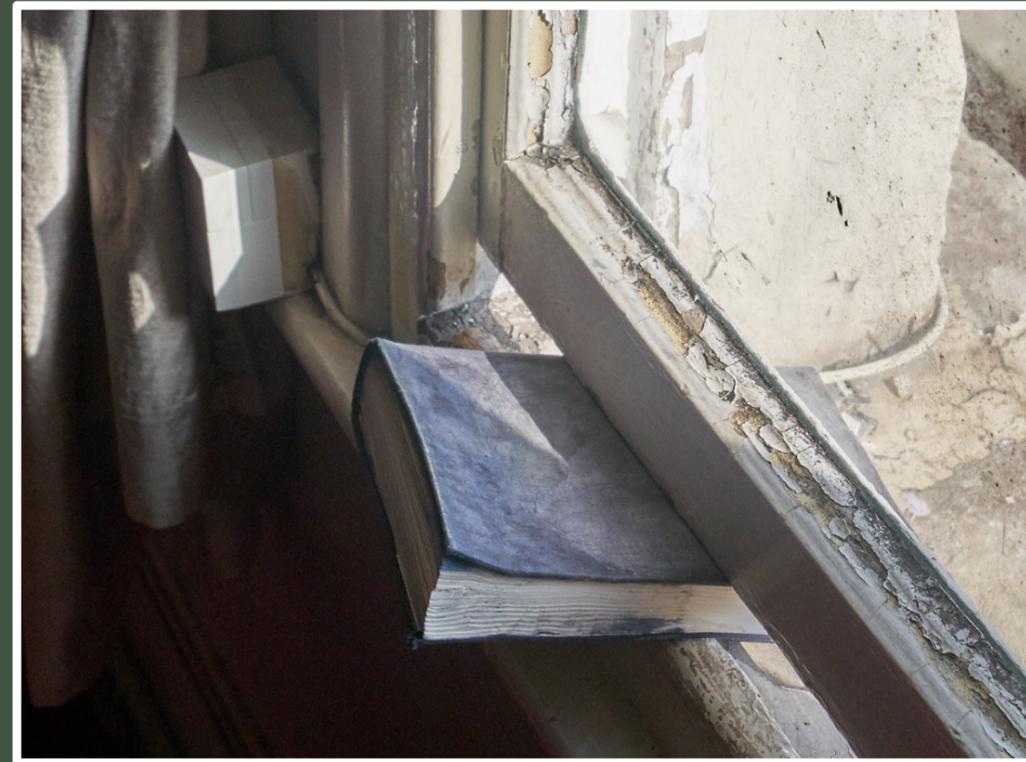
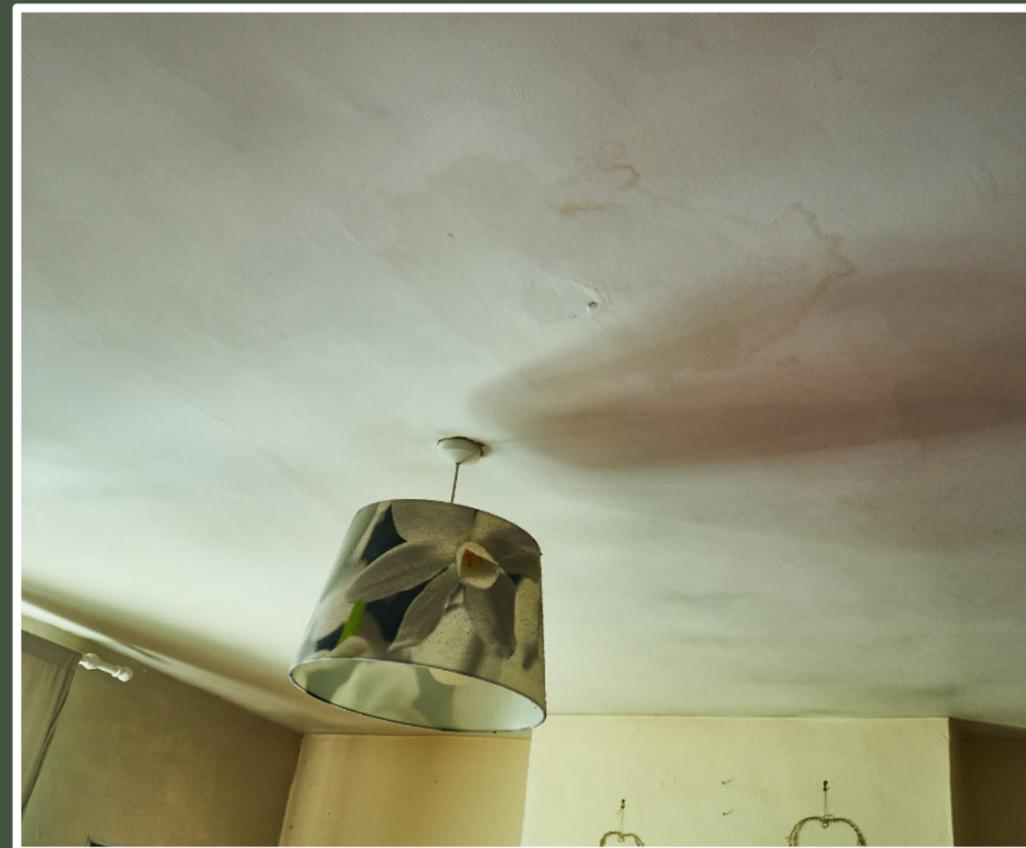
## Living Room

The living room was relatively less trouble. There was water staining in the ceiling from a previous leak, a broken pane of glass in the door, some redundant telephone extension cabling & a loose electrical socket.

Old Blu-tac & picture hooks littered the large walls that needed painting. The only other items were sash windows, which still need their weights adjusting & an annoying rattle in the floor from sudden movement, such as standing up too quickly. The rattle was caused by unsupported copper pipes beneath the floor. If the floor flexed suddenly they would rattle against adjacent hard surfaces.

Removing the living room carpet gave me the opportunity to take up the floorboards & prevent the copper heating pipes from rattling.

A few minor repairs were made but preparing & painting the walls & ceiling was quite an undertaking because of the size of the room.

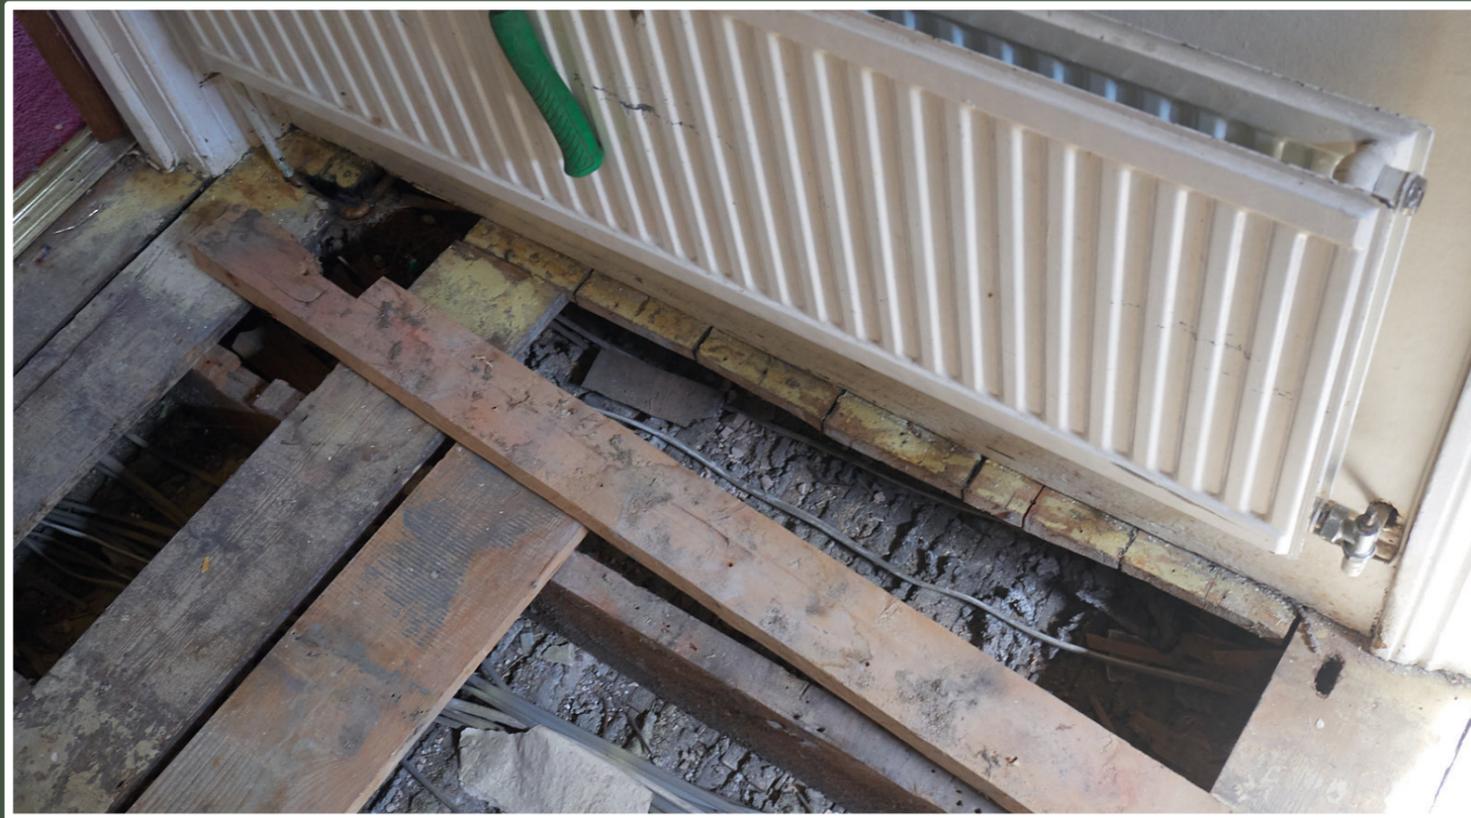
Whilst there were many different construction 'errors', in this example the top photo shows the support that was used, laying on top of the floorboards. It had been nailed in the manner shown in Diagram 1, you may see the nail holes that are still visible. With typical domestic use, the support was destined to fail in a way shown in Diagram 2.
