# First Floor Flat Refurbishment

## Before

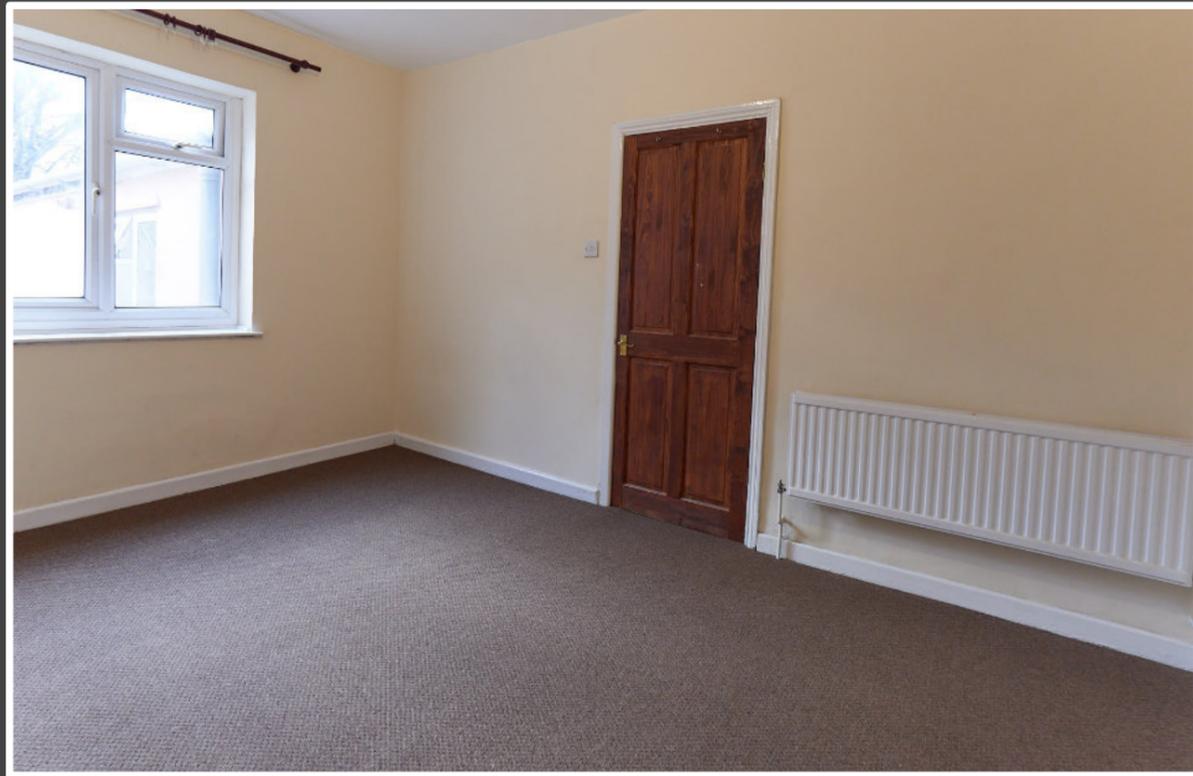
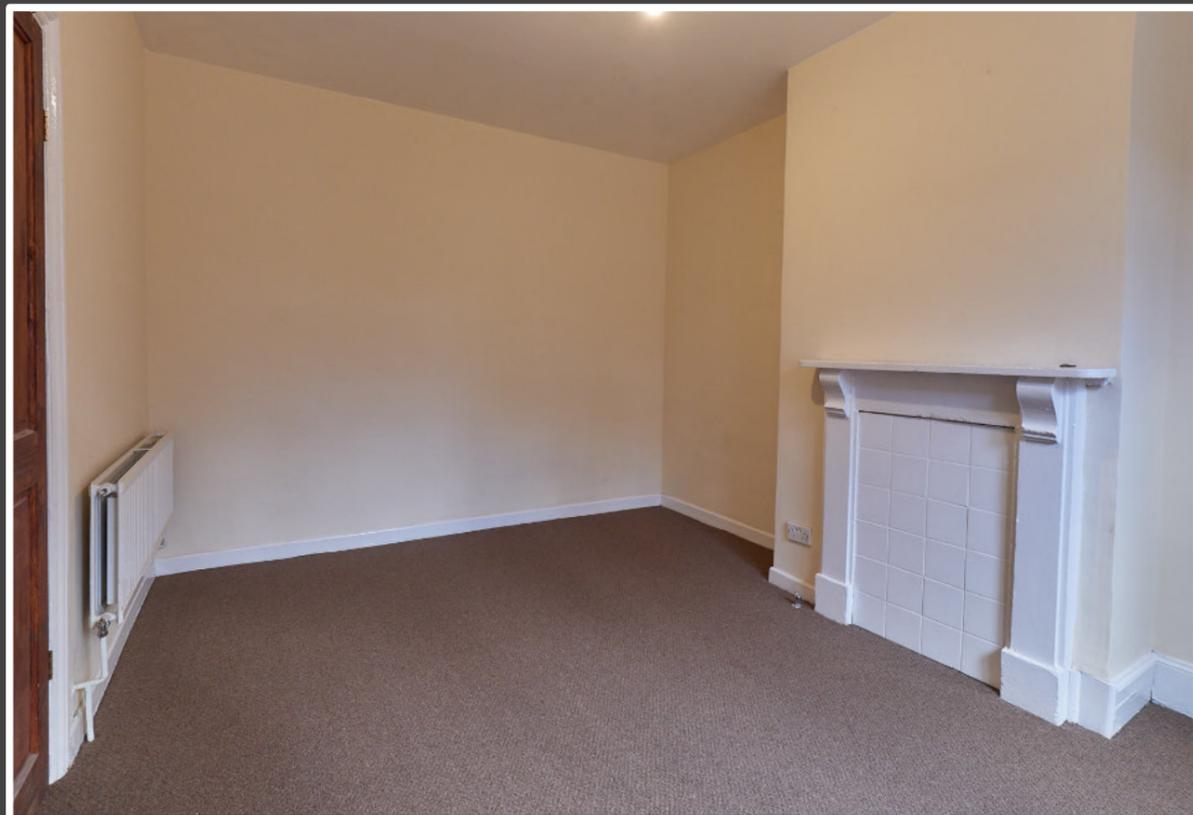
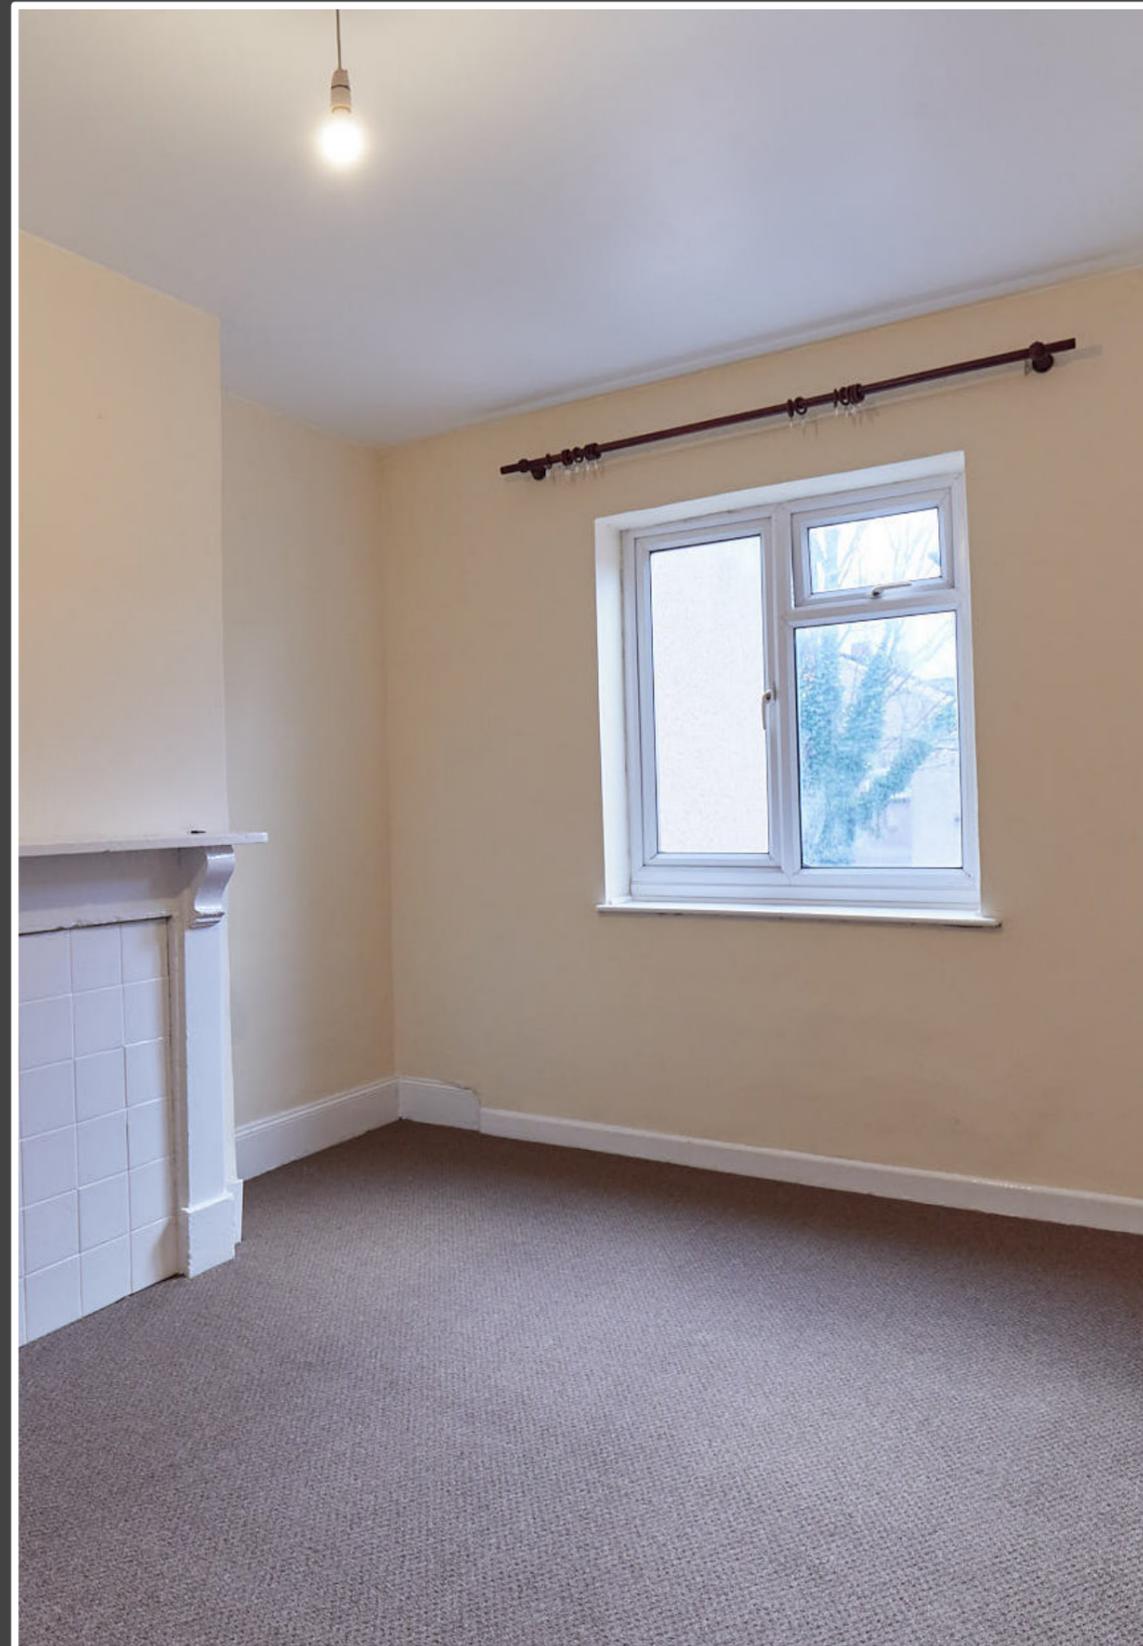
## Bedroom

The window did not get replaced, rather a shame because the seals are still broken & the top light cannot be opened. That said, I believe the damp problem is fixed.

There were many loose & broken floorboards in the bedroom, these were replaced with sheet material which should make for a stiffer & quieter floor & may improve acoustic performance between the flats. Mineral wool was placed in the voids for the same reason.
